Environmental Screening for Surface SARS-CoV-2 Contamination in Urban High-Touch Areas

Authors: Lauren Roppolo Brazell¹, Shawna Stetz¹, Adam Hipp¹, Samantha Taylor¹, Nicholas Stark¹, Katherine Jensen¹, Md Ariful Islam Juel², Patrick Deegan¹, Mariya Munir², Jessica Schlueter¹, Jennifer Weller¹, Cynthia Gibas¹

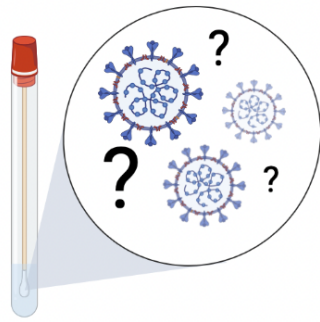
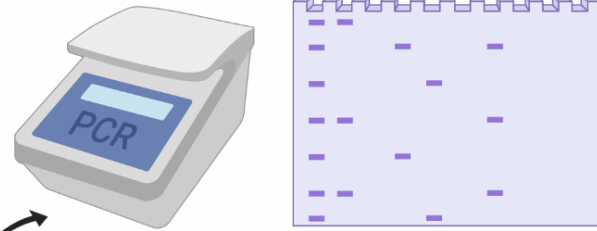
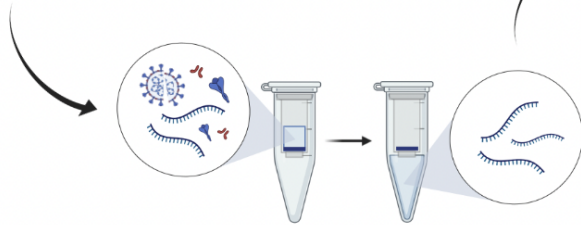
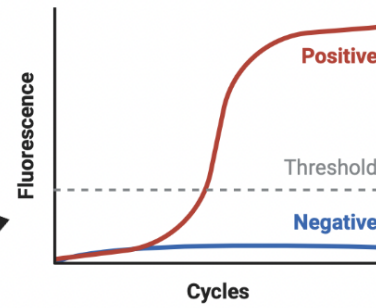
Surface sample collection

Early Pandemic Samples:
Endpoint PCR; detection of SARS-CoV-2

Phase II and Phase III Samples:
RT-qPCR; detection of SARS-CoV-2

Sample processing; RNA extraction

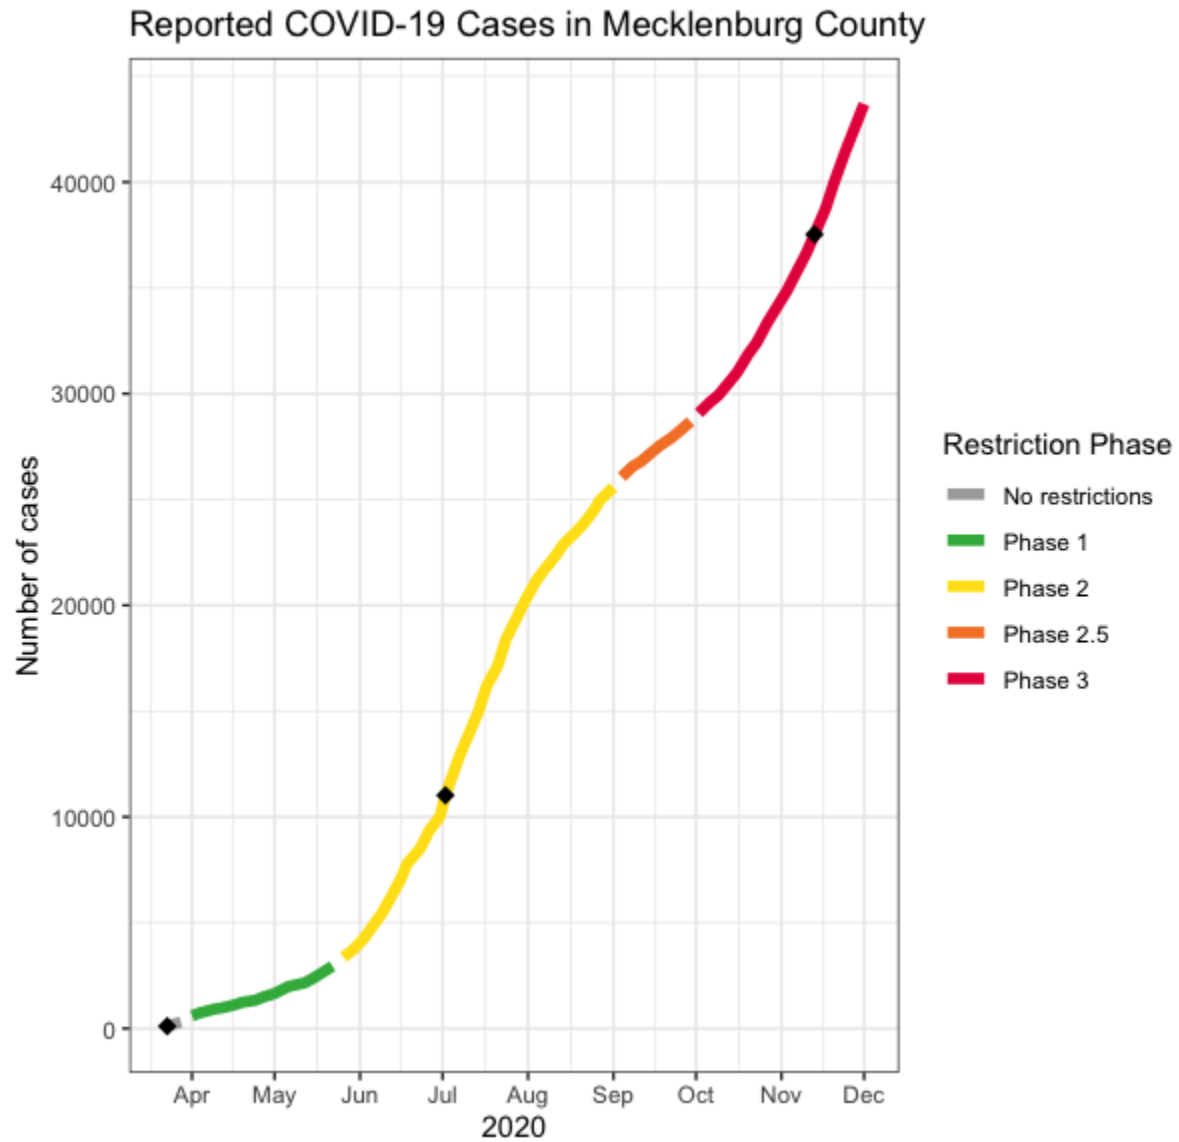
Figure 1. Graphical representation of Mecklenburg County’s reported COVID-19 cases over the 2020 pandemic period. The trendline of cases is segmented by the advent of restriction phases, and black diamond marks indicate when surface samples were collected.

For this study, we collected samples from high-touch surfaces at three different time points during the pandemic [Figure 1]. As the University was closing down and students were moving off campus, we swabbed high-touch surfaces on campus buses as well as surfaces in public areas where students frequently gather. In Phase II, during late July, we swabbed high-touch surfaces on CATS buses, Lynx light rail train cars, and paratransit vehicles. Samples were collected at the end of daily operations, before vehicles were cleaned and sanitized. In Phase III, during mid-November, we again collected samples from CATS vehicles, this time both before and after cleaning. Samples were analyzed using PCR-based molecular detection with standard CDC research use only (RUO) reagents [16]. While a small number of SARS-CoV-2 positive samples were detected among various sites during Phase I and Phase III, the vast majority of sites sampled were free from detectable contamination with SARS-CoV-2.

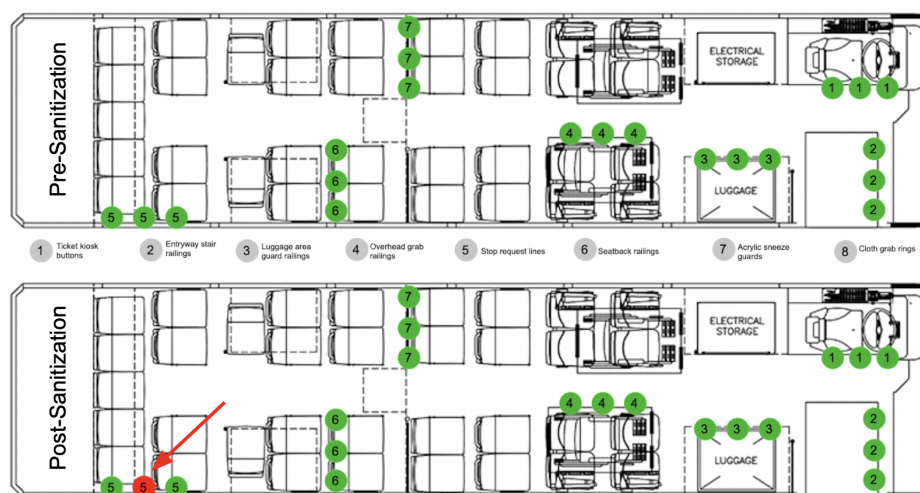
Figure 3. Illustration of sampling locations on the CATS buses [18]. Sites are labeled 1-8 on each vehicle, both before and after routine sanitization. A site with a green dot indicates that there was no presence of SARS-CoV-2 RNA recovered from the surface, and a site with a red dot indicates that there was presence of SARS-CoV-2 RNA recovered from the surface. Here, the stop request line at the back of bus 2 after cleaning tested positive for the presence of SARS-CoV-2 RNA.

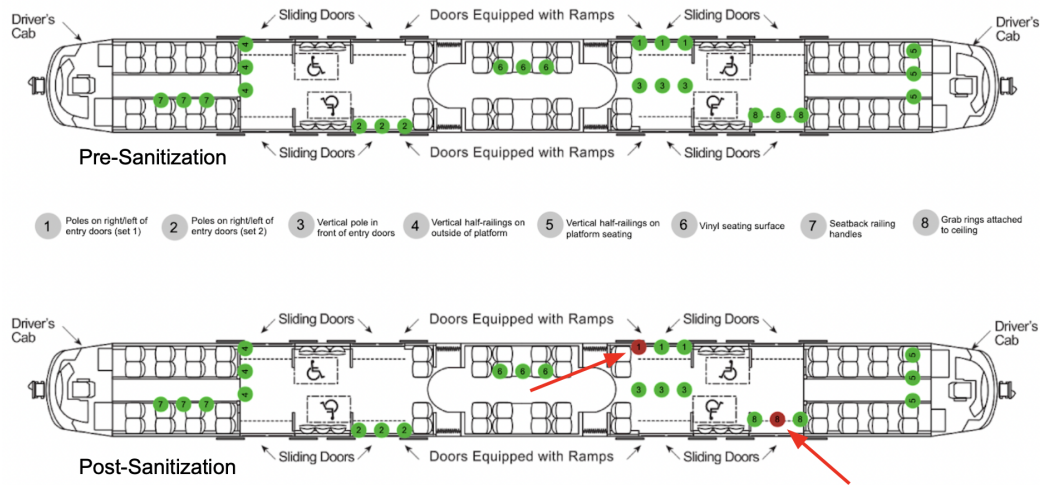
Figure 4. Illustration of sampling locations on the CATS Light Rail trains [19]. Sites are labeled 1-8 on each vehicle, both before and after routine sanitization. A site with a green dot indicates that there was no presence of SARS-CoV-2 RNA recovered from the surface, and a site with a red dot indicates that there was presence of SARS-CoV-2 RNA recovered from the surface. Here, the poles on the right/left of the entry doors on train 1 and the grab rings attached to the ceiling on train 2 tested positive for the presence of SARS-CoV-2 RNA.

units of area. The site with the largest number of recovered viral RNA copies/M² when using the N1 primer/probe set was 1.6×10^5 ; a set of stainless steel grab poles on the right and left of the entryway door on the second sampled train. When using the N2 primer/probe set, this same site showed a viral RNA copy recovery of 1.7×10^4 copies/M². The remaining two sites showed less variation in copies per area, with the vinyl grab ring showing 4.7×10^4 copies/M² using the N1 primer/probe set, and the vinyl-covered stop request line showing 2.3×10^4 copies/M² using the N2 primer/probe set.

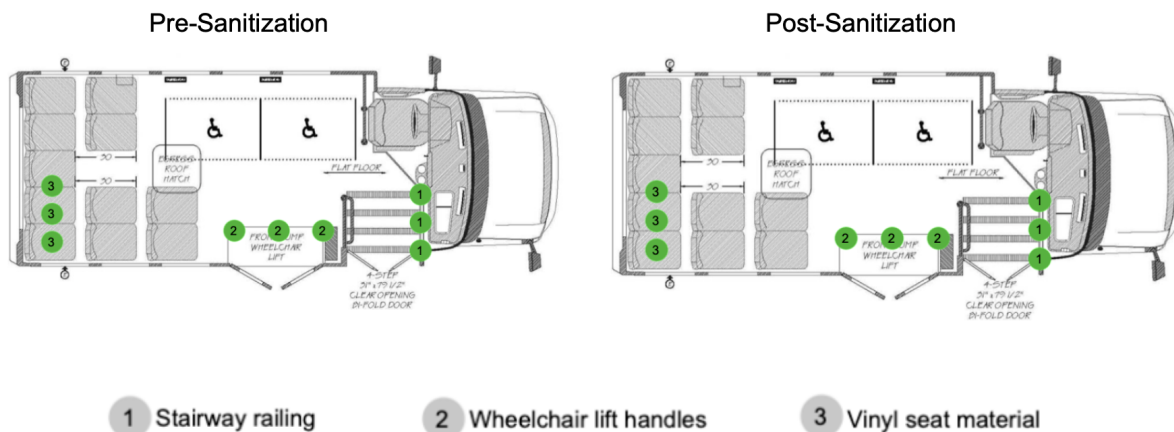
Figure 5. Illustration of sampling locations on the CATS paratransit vehicles [20]. Sites are labeled 1-3 on each vehicle, both before and after routine sanitization. A site with a green dot indicates that there was no presence of SARS-CoV-2 RNA recovered from the surface, and a site with a red dot indicates that there was presence of SARS-CoV-2 RNA recovered from the surface.

In order for a sample to be considered positive, each of the three replicates from the qPCR assay must show that it has crossed the cycle threshold (Cq) at or below 40 cycles per CDC guidelines [15]. The samples collected on the stop request line on the second bus showed Cq values consistent with a positive in all three wells for the N2 primer pre-sanitization [Figure 3; Table 6], and the grab rings on the samples collected from the second train showed Cq values consistent with a positive for all three wells for the N1 primer post-sanitization [Figure 4; Table 6]. The sample collected on the grab poles on the right/left of the entryway doors on the first train showed Cq values consistent with a positive result in all three wells for both the N1 and N2 primer, post-sanitization [Figure 4; Table 6]. None of the samples collected from the paratransit vehicles showed any signal in the qPCR analyses using IDT's N1 or N2 primer [Figure 5; Supplementary Table 2].

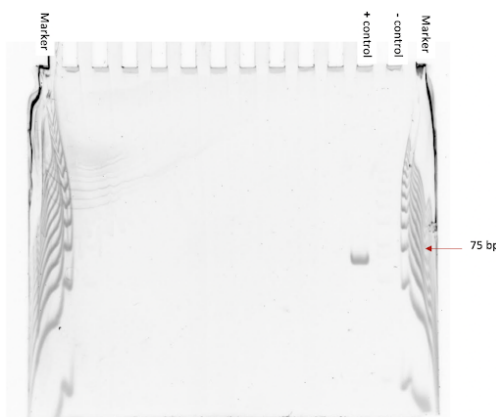
Supplementary Figure 1. Example gel image depicting all components indicative of a successful experiment. In this image, the first and last lanes contain the 25 base pair ladder, the 75bp band is indicated. The 2019-nCoV's specific N1 primer produces a PCR product that is 72bp in length, and the 2019-nCoV's specific N2 primer produces a PCR product that is 67bp in length. The second to last lane containing the negative control is completely blank, and the positive control shows a band around the 75 base pair mark. A band here indicates a positive result; in the case of our experiment, this would indicate that there is presence of SARS-CoV-2 viral RNA.

At the beginning of the pandemic, we were able to demonstrate that the endpoint PCR method performed as expected [Supplementary Figure 1], and to successfully detect the presence of SARS-CoV-2 RNA [Figure 2] from surface samples collected on campus using endpoint PCR alone. This method detected SARS-CoV-2 in 11 of 70 samples using the RUO N2 primers, from locations on campus at UNCC [Table 3; Table 4; Figure 2]. Of the 11 that were deemed positive using the endpoint PCR detection method, 3 of those were later confirmed positive for SARS-CoV-2 using the qPCR detection method [Table 5].
