Microbial contamination of powered air purifying respirators (PAPR) used during the COVID-19 pandemic: an in situ microbiological study

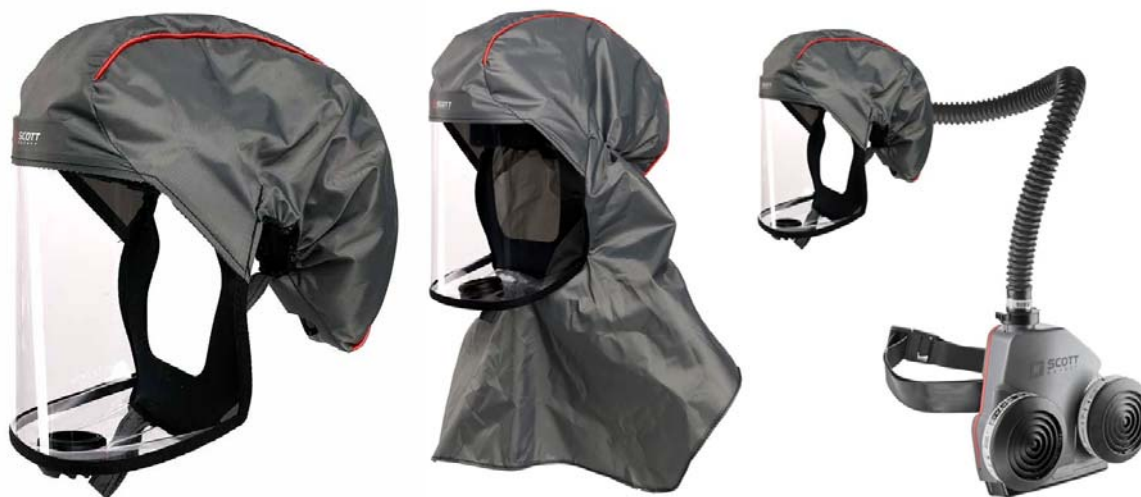
There are currently approximately 100 PAPRs in our Trust; PAPR assemblies consist of a fan unit with battery pack and filters, connected via corrugated tubing to a headtop or hood (figure 1). The majority of hoods are *3M Scott Safety FH1 headtops*, the rest are *3M Scott Safety FH2 PAPR headtops* (3M Scott, Skelmersdale, UK). The *3M Scott Safety FH1 headtop* is a half hood that provides a loose seal around the face; the *3M Scott Safety FH2 PAPR headtop* is similar to the *FH1* but, in addition, has a shoulder cape that provides neck and shoulder protection. The filtered air, under positive pressure is supplied to the wearer; this and the wearer's exhaled breath is expelled around the edges of the hood and through an unshrouded expiratory valve at the bottom of the visor component of the hood. The hoods consist of a clear polyethylene terephthalate glycol visor, stitched to fabric, with a neoprene margin that sits against the wearers face. These PAPR and hoods were originally developed to provide respiratory protection in industrial use to help combat pulmonary contamination by inanimate particulates; their use has been adapted for the current circumstances during the COVID-19 pandemic by upgrading the filters attached to the fan unit.

Figure 1. 3M Scott FH1 and FH2 Headtops and PAPR arrangement

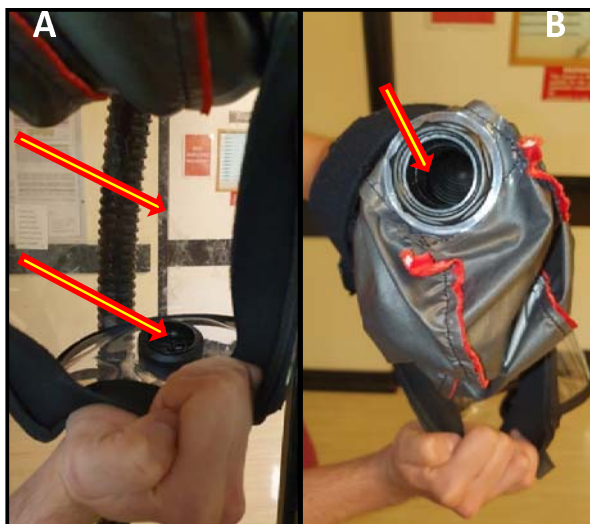
1. Identify power hood
2. Label power hood (same name as sample)
 - E.g. Pye_PRH_1 (Pyecombe, PRH, Hood 1)
 - E.g. ICU_RSCH_3 (ICU, RSCH, Hood 3)
3. Don PPE:
 - Hood holder – fresh sterile gloves, eye protection, and FFP3 respirator
 - Swab taker – fresh sterile gloves, eye protection, and FFP3 respirator
 - Swab labelling & bagger – non-sterile gloves, eye protection, and FFP3 respirator
4. Prepare power hood and hold as per illustration

5. Swabbing
 - plastic visor and the exhalation vent
 - take **BLACK** (bacterial/fungal) swab and drip on sterile 0.9% NaCl
 - Wipe swab over (inside of) clear face piece and expiration vent
 - take **GREEN** (viral/COVID) swab and drip on sterile 0.9% NaCl
 - Wipe swab over (inside of) clear face piece and expiration vent
 - Corrugated tube at hood end
 - take **BLACK** (bacterial/fungal) swab and drip on sterile 0.9% NaCl
 - Wipe swab around and 10 cm in to corrugated tube
 - take **GREEN** (viral/COVID) swab and drip on sterile 0.9% NaCl
 - Wipe swab around and 10 cm in to corrugated tube
6. Labelling samples
 - E.g. Pye_PRH_1_Bact/Fung_visor = Pyecombe, PRH, Hood 1, bacterial/fungal swab from visor
 - E.g. ICU_RSCH_3_Viral_tube = ICU, RSCH, Hood 3, viral & COVID swab from corrugated tube
7. Bagging
 - Each sample must go in its own labelled bag

The hood-holder manipulated the mask to allow the swab-taker access to the target area to take samples (Figure 2). Each PAPR was swabbed for bacteria, fungi, respiratory viruses (extended respiratory panel) and SARS-CoV-2. Bacterial and fungal samples were taken with Transwab® Amies Charcoal swabs (MW171, Medical Wire & Equipment, UK), and viral samples taken with Sigma Virocult® swabs (MW951S, Medical Wire & Equipment, UK).

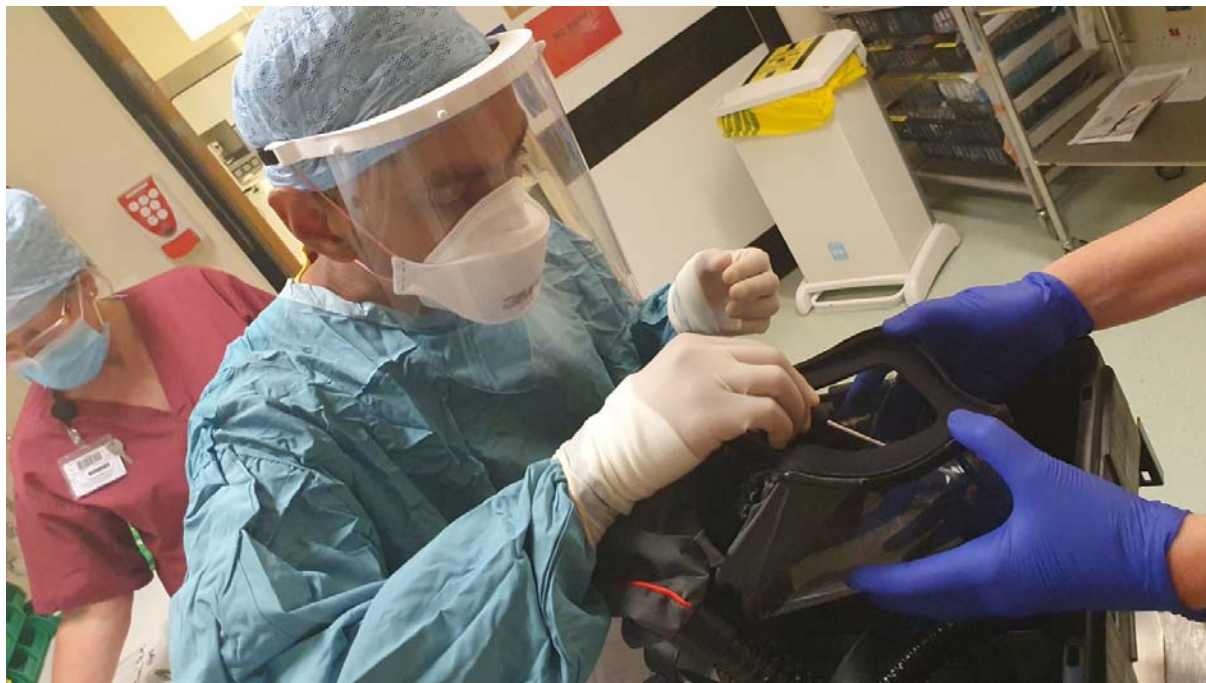
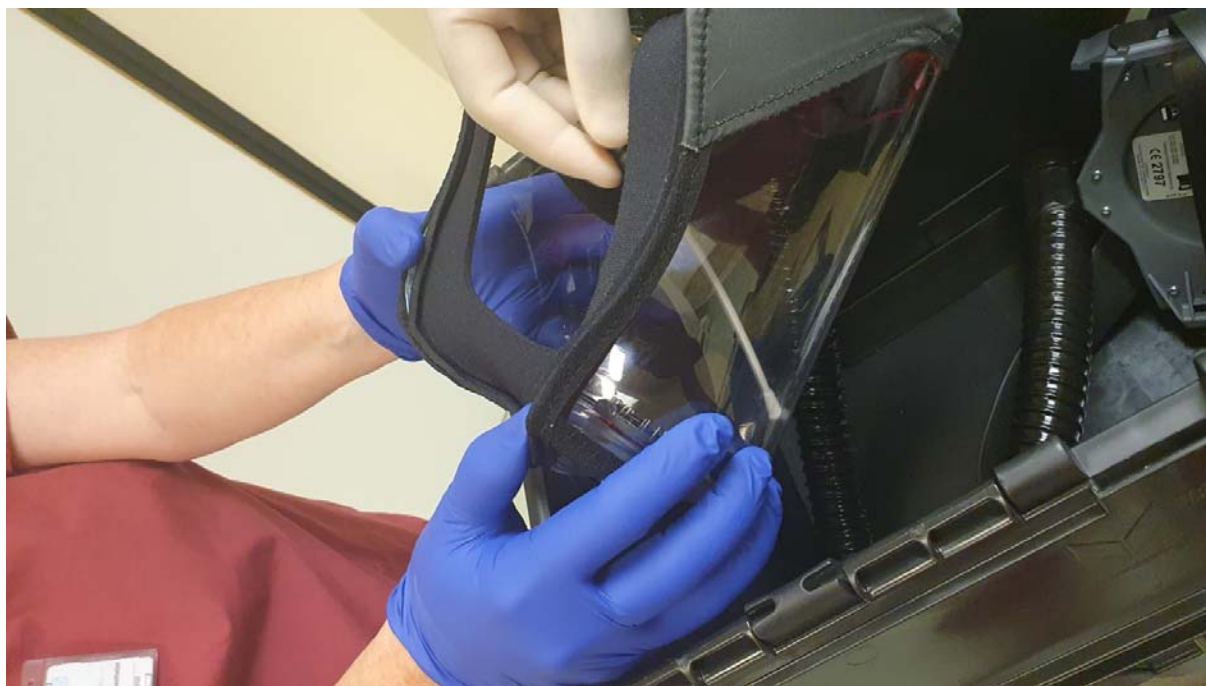
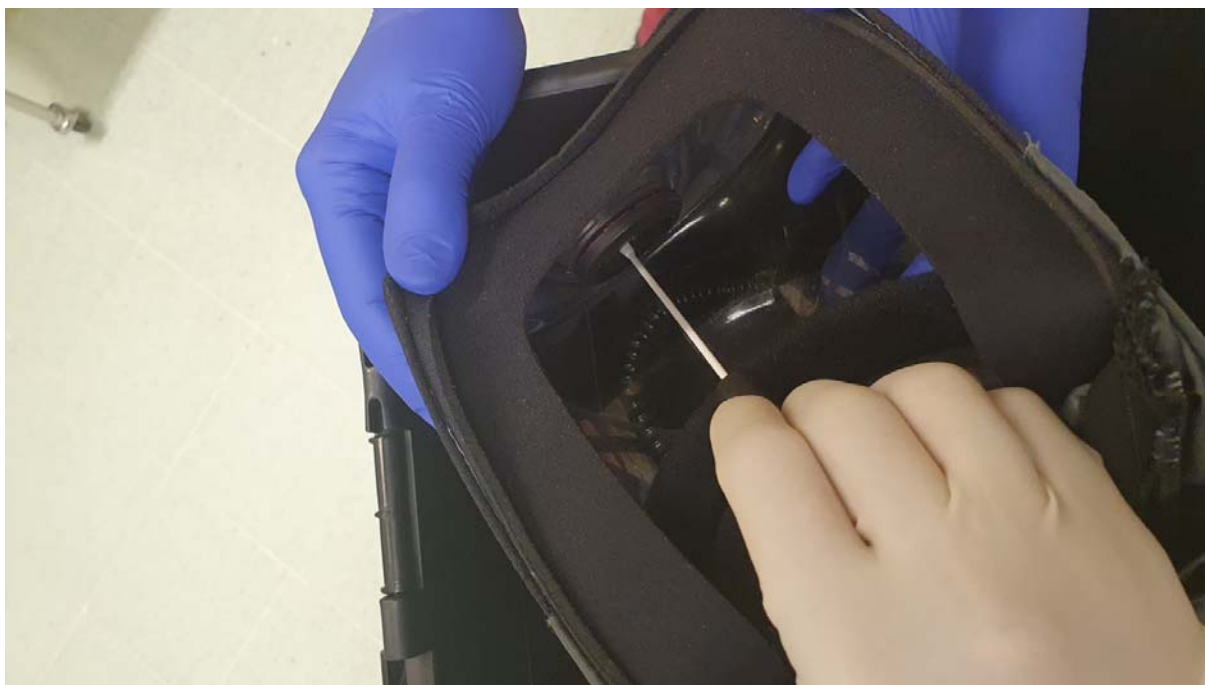
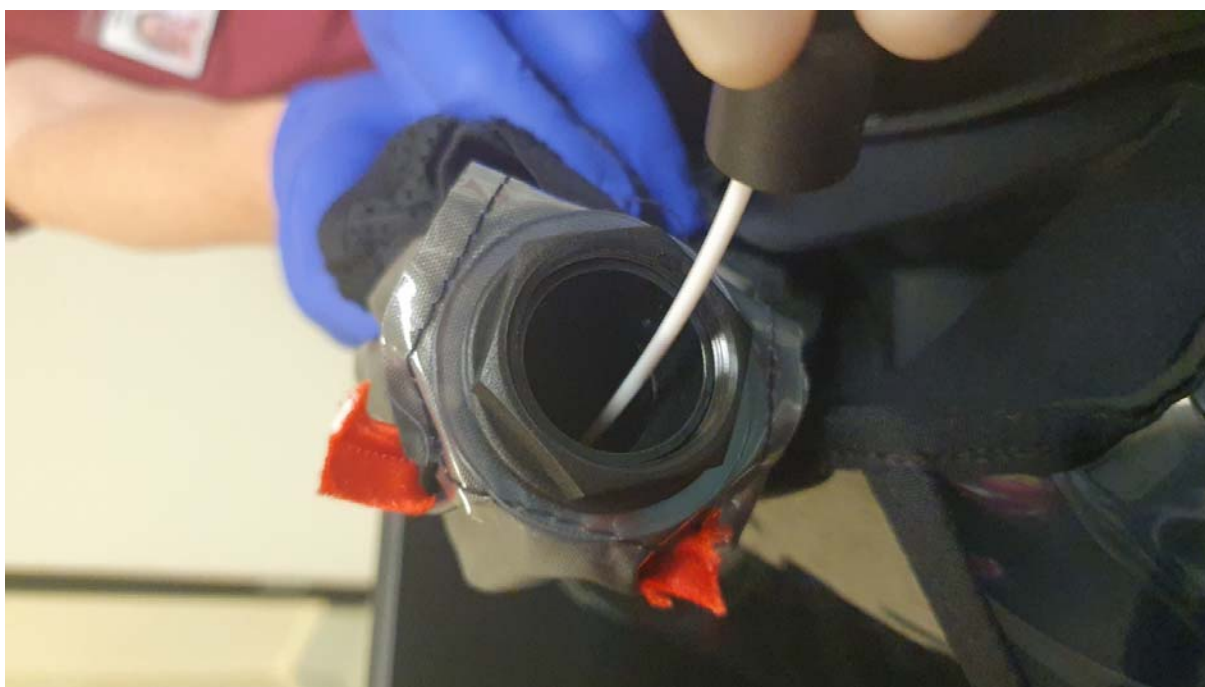
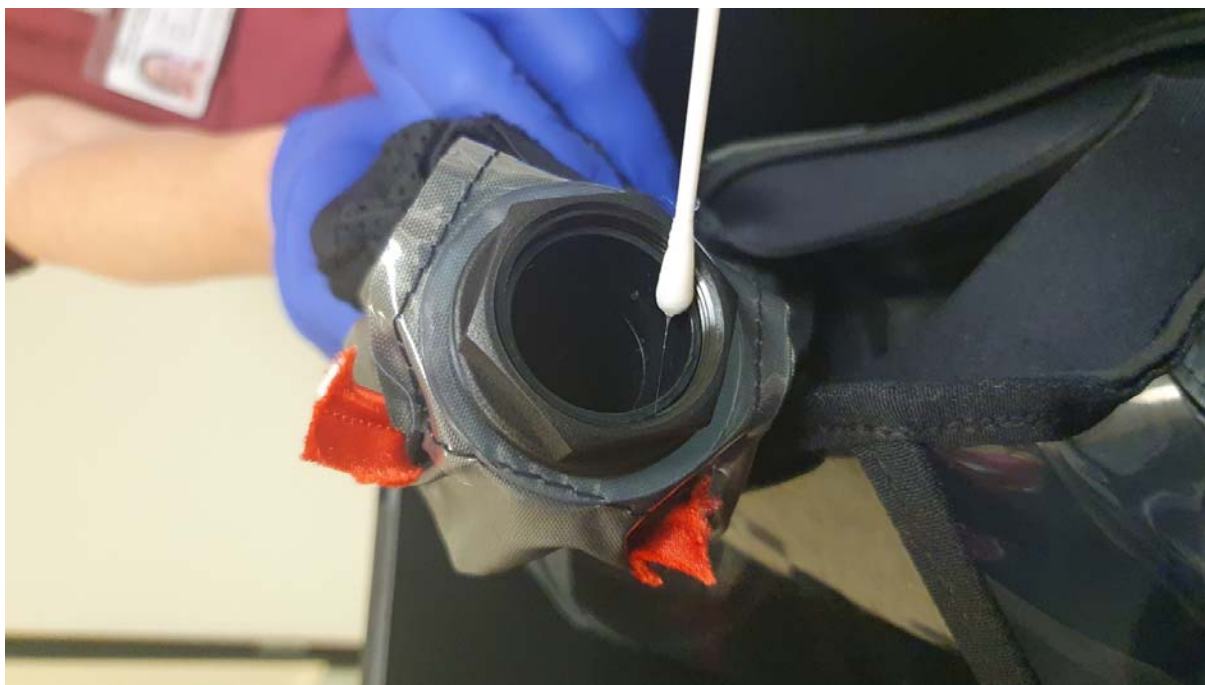
Supplementary information 3. Swabbing PAPP hoods and tubing (simulated)

Swabs were moistened with sterile 0.9% sodium chloride solution. Swabs were taken from two pre-defined areas: first, inside of the clear plastic visor including the expiratory valve, and second, inside the corrugated tube attached to the hood. The visor and expiratory valve were divided into two halves, one for the charcoal swab and one for the viral swab. The expiratory valve was swabbed first with care taken to apply the swabs uniformly over the surface and then over the respective side of the visor in linear, up-down, fashion with care taken to access any corners and cover the full area of the visor. The corrugated tubes were also divided into two halves, one for each type of swab. The swab was passed from the rim down to approximately 10cm, the length of the swabs, with care taken to swab within the ridges of the corrugations.
