Carbon dioxide, COVID-19 and the importance of restaurant ventilation: a case study from Spain approaching Christmas 2021

Teresa Moreno¹, Wes Gibbons²

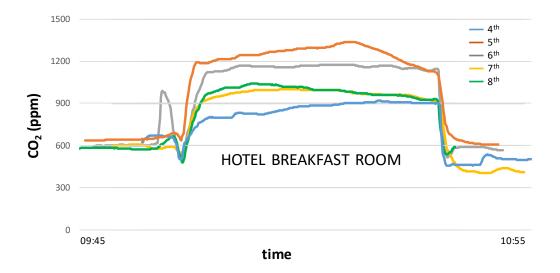
Figure 1: CO_2 concentration curves for hotel breakfast periods on the five days 4th-8th December 2021. The curves record initial hotel room conditions (600-650ppm) interrupted by a brief trough marking a short outdoor walk to the breakfast room inside which CO_2 levels rose steeply, especially on the 5th (Day 2 on Table 1) when the room was fully occupied. The pre-breakfast transient peak on the 6th records entry into the hotel bar area. See text for details.

Table 1 and Figure 1 summarise the data from the hotel breakfast room. This was a large room on the first floor, connected to the rest of the hotel by a door leading to a staircase down to the hotel ground floor (not directly to outside air). This door was kept fully open throughout the breakfast period, but all six windows were kept closed. There was no CO₂ meter in the breakfast room, although one was operating in the ground floor bar below. All CO₂ measurements for this study were taken during the same breakfast time-slot (10.00-10.45 am) and from a similar part of the restaurant and at a height around 50cm above the floor. Seating protocols ensured that tables were separated by >1m and they were required to wear masks when helping themselves to the food buffet. Most guests wore correctly fitted masks when standing at the buffet, although there were a few notable exceptions.

The lowest CO₂ concentrations in the hotel breakfast room (average 868ppm: Table 1) were measured at the beginning of the holiday period (4th), before hotel occupancy numbers reached their peak. During this first breakfast CO₂ levels climbed slowly to a maximum value of 919ppm (Table 1). In contrast, the following day (5th), after high hotel occupancy levels during the Saturday night, the breakfast room was exceptionally busy (CO_2 average 1237ppm). Under these conditions CO_2 concentrations at 10.00 were already approaching 1200ppm and then climbed to a peak of 1342ppm in the fully occupied room before slowly declining as people began to finish their breakfast and leave the establishment (Figure 1). On the morning of the bank holiday on the 6th December CO₂ levels were again high (Day 3 average 1140ppm: Table 1), falling to around 950ppm average on the remaining two days (Days 4 and 5: Figure 1). The atmospheric stability of this indoor setting over the five mornings was reflected by minimal variation in both temperature and RH. Apart from the exceptionally busy Day 2 (marked by much customer and staff movement and occasional toast burning events), average PM_{2.5} levels also showed little variation on a given morning (varying by only $2-4 \,\mu g/m^3$: Table 1). With the windows closed and the internal entry door left open, the dominant control on CO₂ concentrations appears to have been the number of guests attending breakfast. On the morning of the second day (5th), the headwaiter was made aware of the fact that the ventilation could be better, and agreed with this observation. However, nothing obvious was changed on subsequent mornings: in particular all windows remained closed.

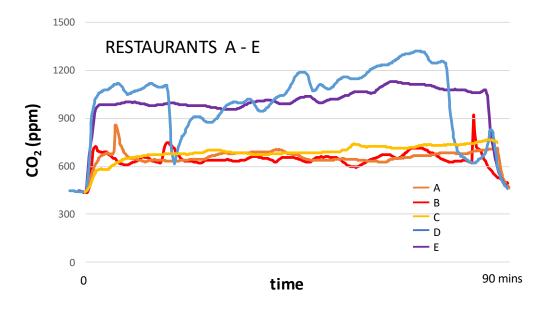
Figure 2: CO₂ concentration curves for the five restaurants sampled during the study. A, B and C record good, generally stable ventilation conditions, with average $CO_2 < 700$ ppm, in contrast to Restaurants D and E. Whereas Restaurant D made sporadic efforts to ventilate the establishment by opening the front door (marked by two precipitate falls towards 600ppm), Restaurant E kept doors and windows closed. See text for details.

Five restaurants were chosen to sample contrasting atmospheric scenarios (Table 2 and Figure 2). The data collected indicate that three of these restaurants (A, B, C: Figure 2) were well ventilated, maintaining stable CO_2 concentrations which averaged below 700ppm and never reached maxima of 1000ppm (Table 2), despite the fact that each establishment was different in character. Restaurant A was small, with few (<20) customers and with the front door continuously held slightly open it registered CO_2 average levels of 665ppm, although combined with relatively high $PM_{2.5}$ concentrations attributed to cooking emissions. Restaurant B was a narrow bar restaurant (<20

clients indoors), with tables separated by screens, the front door fully open, and showed similar air quality conditions to Restaurant A (Table 2). Restaurant C was a large, busy open-plan converted market building with multiple food outlets and two floors (the monitor recorded on the upper floor) and a prominent new ceiling HVAC system. Despite a multitude of customers and staff housed in this establishment, its large size combined with the HVAC system successfully kept average CO₂ levels at 684ppm and average $PM_{2.5}$ concentrations at $9\mu g/m^3$ (Table 2). Despite the considerable differences between these three establishments, all of them thus managed to maintain stable, relatively low CO₂ levels, punctuated only occasionally by transient peaks due to people clustering near the monitor.

In contrast, two of the restaurants failed to maintain average CO_2 concentrations below 1000ppm during the meal (D and E: Table 2). In the case of Restaurant D, this was a medium-sized establishment which was fully occupied for much of the time, although maintaining correct adherence to table separation rules. The restaurant owner was aware of the need for ventilation, which she attempted to achieve by fully opening the front door from time to time, allowing a blast of cold air into the room that was not appreciated by some guests. Carbon dioxide concentration data for Restaurant D are shown on Figure 2 and show levels of around 1050ppm on entry into the establishment, with slight declines in the curve recording the arrival of guests briefly opening the

front door. Ventilating the restaurant suddenly by fully opening the front door caused CO_2 levels to drop immediately to 600ppm (Figure 2), but after this levels rose rapidly, interrupted by further guest arrivals, to peak at 1310ppm. A repeated brief ventilation episode suddenly reduced CO_2 concentrations once again to 600ppm before beginning another cycle of rising levels (Figure 2). Another notable characteristic of this restaurant was its high levels of average and maximum $PM_{2.5}$ (Table 2).

The other establishment failing to ensure minimum levels of CO_2 was smaller (Restaurant E) and, although much less busy (<20 clients), had chosen to keep the front door firmly closed. This scenario generated stable but high levels of CO_2 which were nearly 1000ppm upon entry and subsequently rose gradually to peak at 1116ppm (Figure 2; Table 2).
